EPA/MEW All Parties Meeting

May 6, 2014

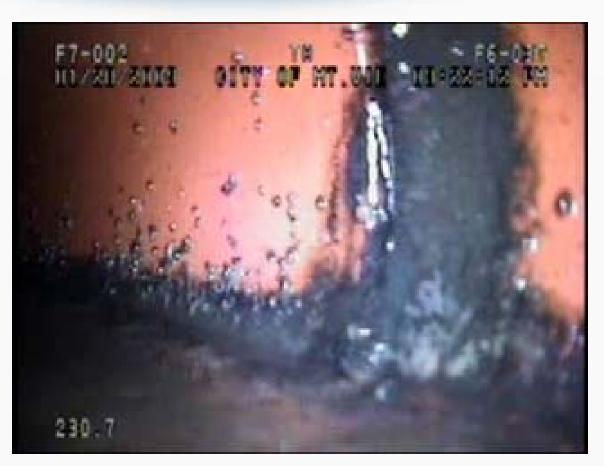
Example: F7-002 to F7-037

Manhole Number: F7-002

(13.3) - WATER INFILTRATION

(38.9) - WATER INFILTRATION -

(44.0) - WATER INFILTRATION

(48.9) - WATER INFILTRATION -

(120.9) - WATER INFILTRATION -

(125.3) - WATER INFILTRATION -

(129.7) - WATER INFILTRATION -

(140.8) - WATER INFILTRATION

(141.7) - lateral LEFT GREASE -

(154.4) - WATER INFILTRATION -

(160.4) - WATER INFILTRATION -

(181.0) - WATER INFILTRATION -

(226.9) - WATER INFILTRATION -

(230.7) - WATER INFILTRATION -

(241.5) - WATER INFILTRATION -

(294.7) - END INSPECTION

Total Distance: 294.7
